ANNUAL REPORT FOR 2007

**Third Street Bridge Mitigation Site
New Hanover County
TIP No. U-0092A**

Prepared By:
Natural Environment Unit & Roadside Environmental Unit
North Carolina Department of Transportation
January 2007

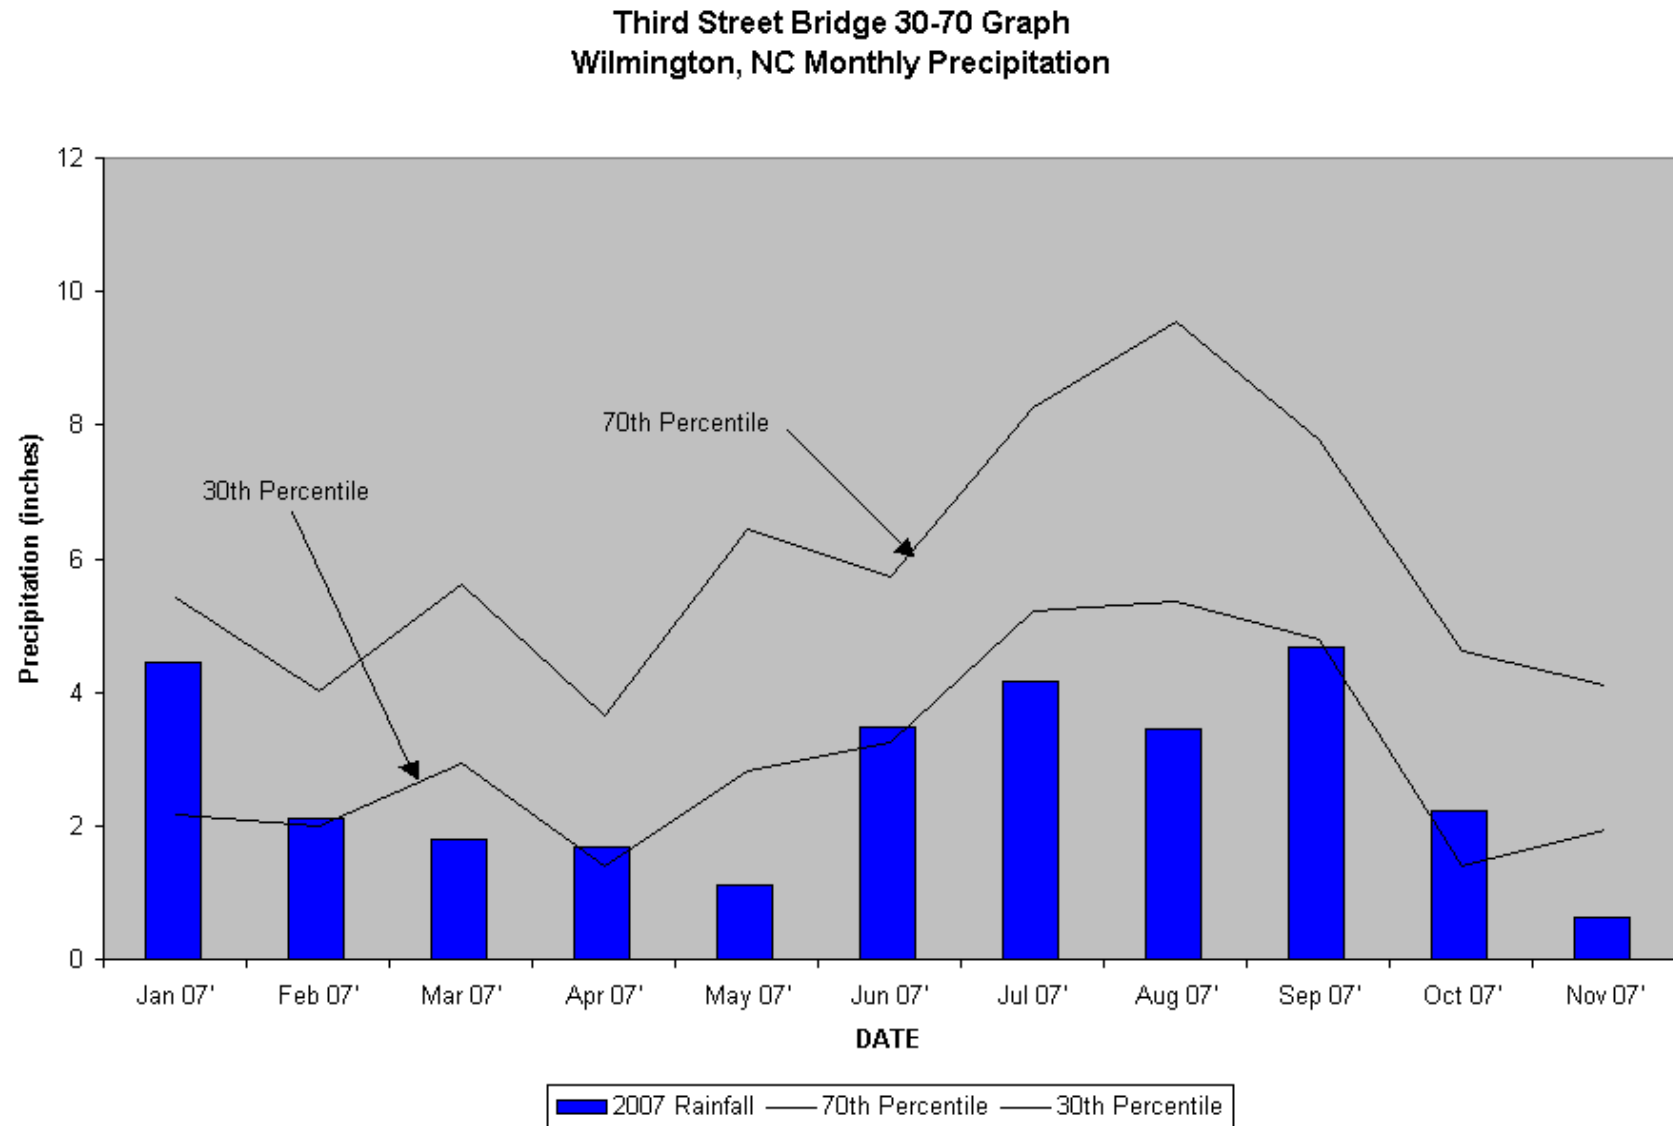
Figure 4. 30-70 Percentile Graph, Wilmington, NC

Figure 4 is a comparison of the 2007 monthly rainfall to the historical precipitation (collected between 1976 and 2006) for Wilmington, North Carolina. This comparison gives an indication of how 2007 relates to historical data in terms of climate conditions. The NC State Climate Office provided all local rainfall information.

This graph is used to indicate the general precipitation conditions for the surrounding area. Overall, 2007 exhibited below normal rainfall. The data obtained in 2007 indicates that rainfall in the months of January and October was normal, however all remaining months in 2007 were below to well below normal.
